SEATTLE CITY LIGHT WORK ORDER #89-5
SEATTLE CITY LIGHT REAL PROPERTY SITE ASSESSMENTS

RAVEN SERVICES CORPORATION
2200 SIXTH AVENUE, SUITE 519
SEATTLE, WASHINGTON 98121
(206) 443-1126; FAX (206) 443-1128

April 28, 1989

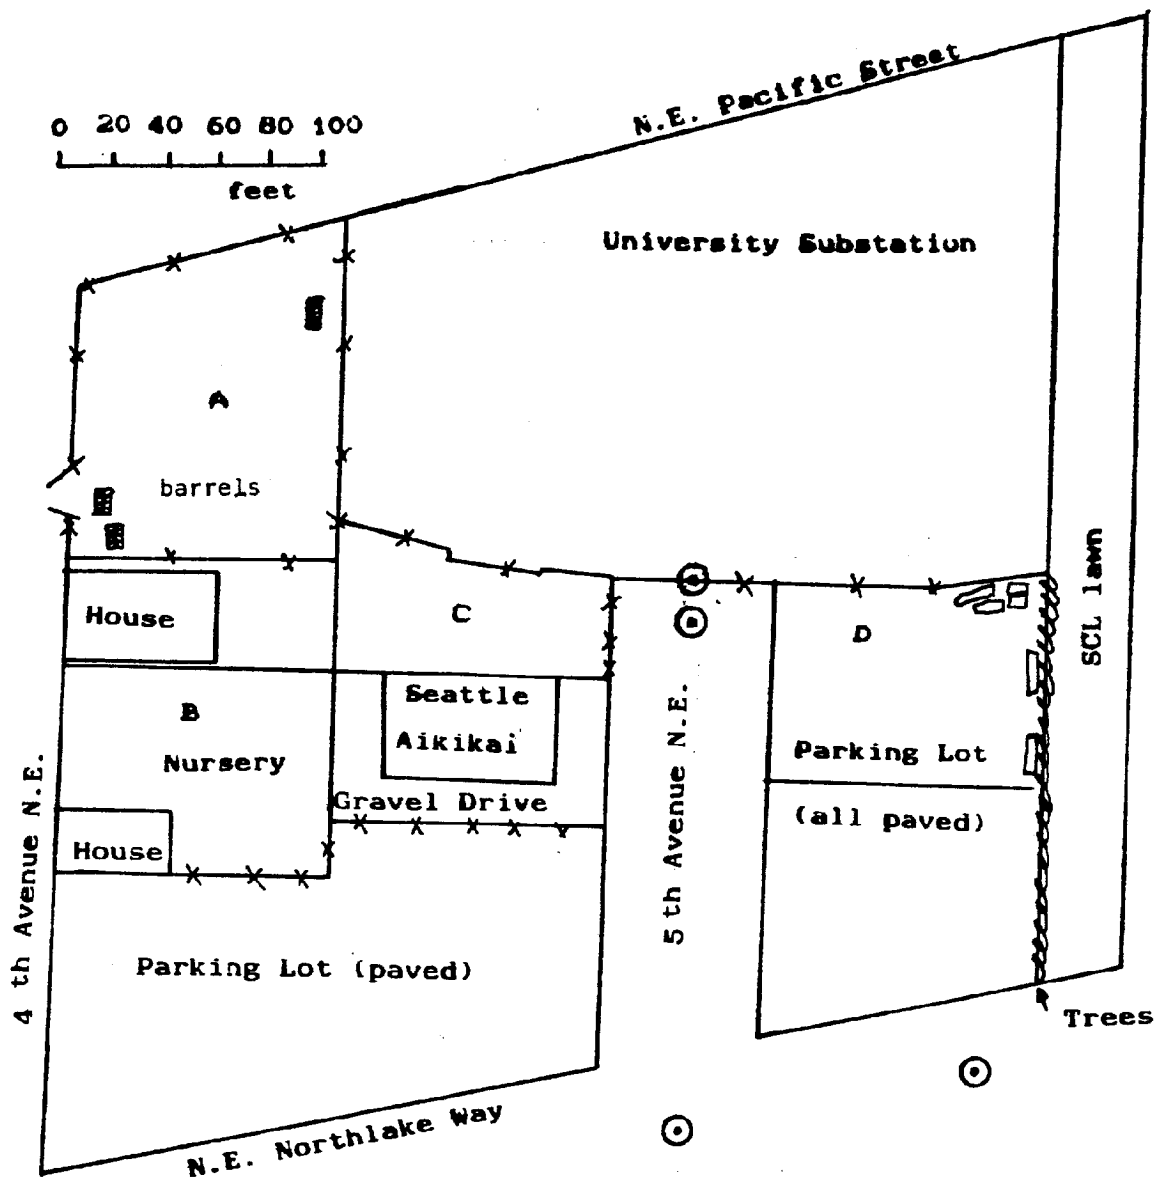
RAVEN SERVICES CORP.		
SCALE: feet	APPROVED BY: <i>MSH</i>	DRAWN BY: LSG
DATE: 4/10/89		REVISED: MTH
Fig. 1 Univ. Sub Environs		
LA TERRE ENVIRONMENTAL CONS.		DRAWING NUMBER: 89-5-1

As shown in Figure 1, property A is privately owned and is the former site of Norton Tile Co. The fence gate has been smashed. Nothing remains on the property except a flatbed truck with a Norton sign on the door, two barrels (55 gal.) and a third rusty barrel. One barrel is open and apparently contains old rainwater with an oily coating on the surface. One barrel appears to be 1/2 full of motor oil. The third has unknown contents and must be cut open. Because of rust, this barrel is not sealed. There are some small (4' X 8') slabs of concrete near the gate and a few square feet of oily black soil around the slabs. No evidence for underground tanks was found. The property is covered with grass and small weeds. The north border is lined with dense blackberry brambles.

Property B is a nursery full of outdoor potted plants. There is a house as shown whose address number is 3814. Both property B and the house to the north have junk ranging from rusty pipes to automobiles around the houses.

Property C is fenced with a cyclone fence and is used for storage of an assortment of frames of thin metal pipes for some unknown purpose. The lot is covered with thin grass above gravelly, sandy soil. The adjacent property appears to be used by persons in the Seattle Aikikai Building (a martial arts school) who occupy the north side of the school.

Property D is entirely paved and contiguous with the property to the south to form a large parking lot. There is a pile of old logs in the NE corner adjacent to the substation.

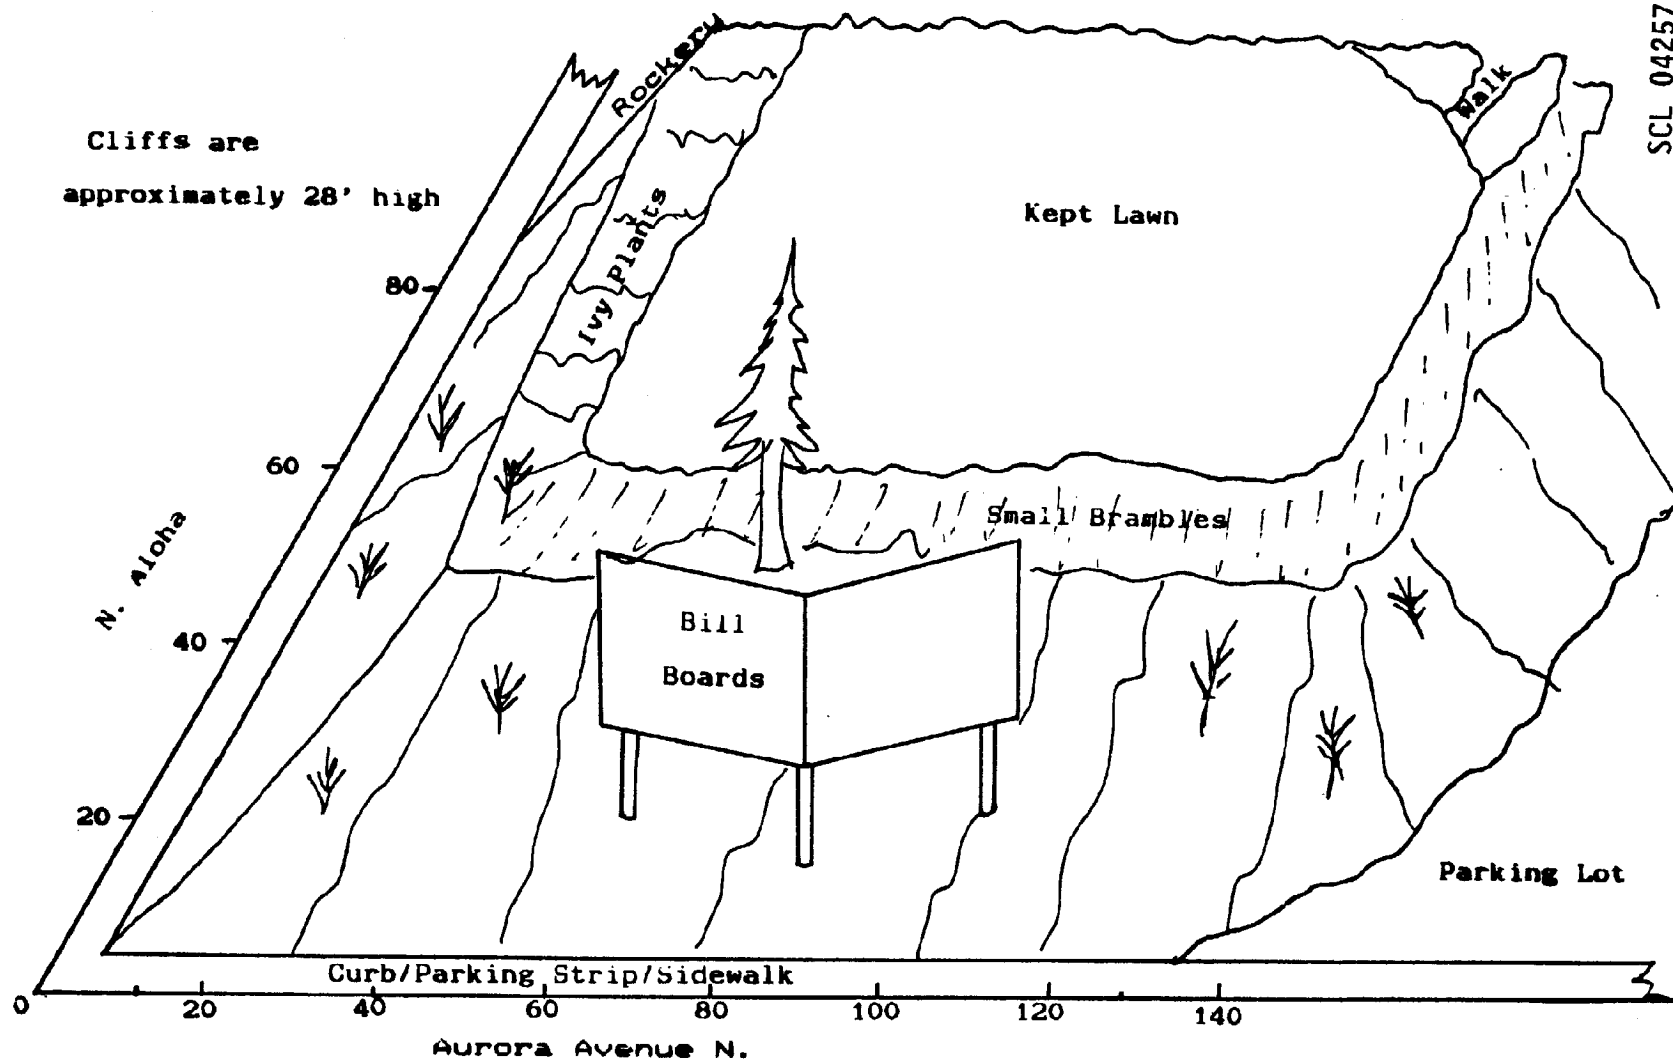
Fig 2. *N. Aloha - Aurora Prop.*

This property is described as a mesa extending east from the condominium whose address is 601 N. Aloha St. The property has become an extension of the back yard of this condominium and is landscaped as such. Scrub trees and grass cover the entire cliff surfaces, but ivy plants have been cultivated along the south edge of the plateau, and short brambles have been cultivated along the east and north edge. The billboards are supported by steel I-beams sunk in the cliffside soil. There is no evidence of any industrial activity or hazardous material spillage either current or historic. Herbicides, however, may have been applied by the landscaper. The street corner, shown in Figure 2, is a right angle street, but is drawn at 60° angle to show the perspective of the cliffs.

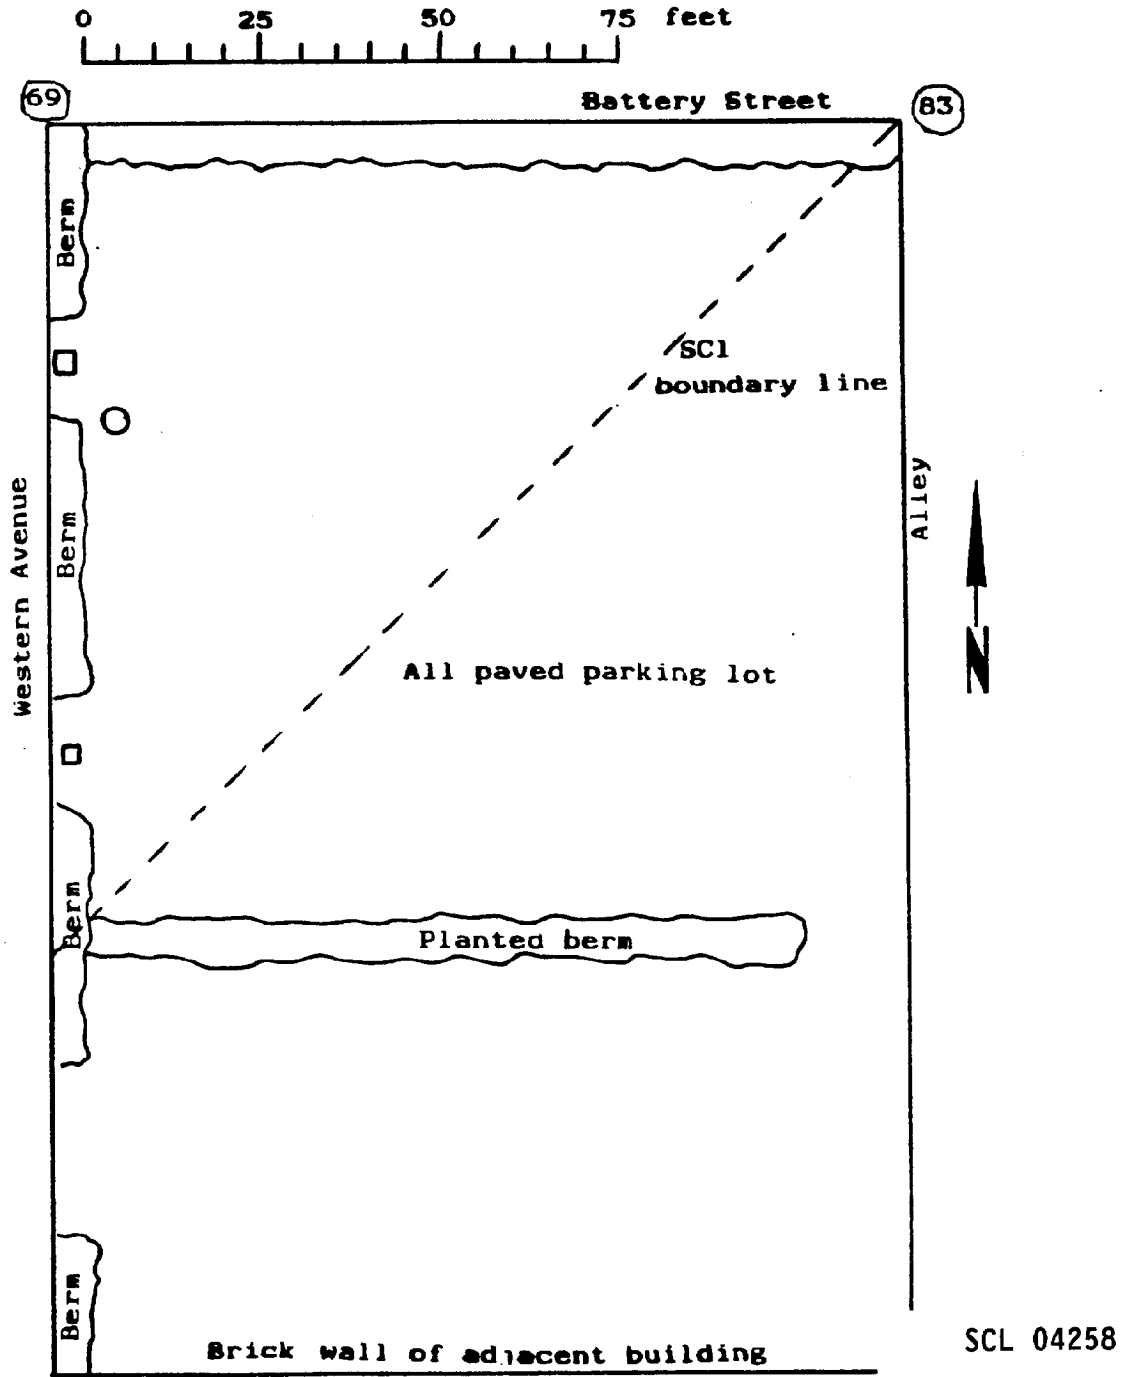
Fig 3. Battery Sub Prop.

This site is an entirely paved and recently landscaped parking lot [Central Park Co.]. The only exposed soil is the recently composted berm material. The drainage of the lot appears to be in excellent order. Elevations that appear on the map shown in Figure 3 were taken from the 1956 substation map and may have changed after the more recent paving.

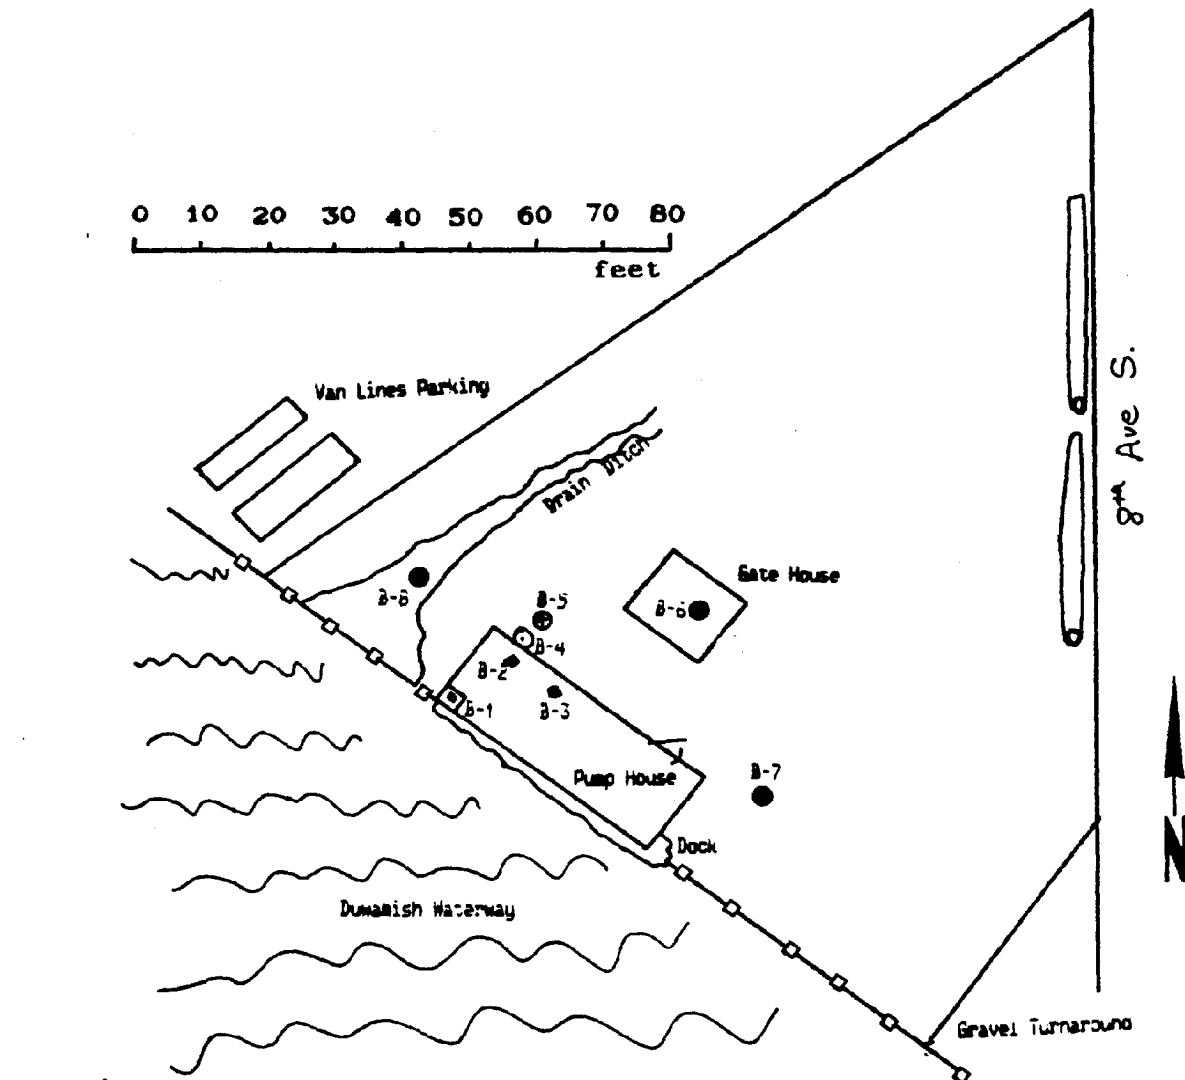
RAVEN SERVICES CORP.			
SCALE: feet	APPROVED BY: <i>M. J. H.</i>	DRAWN BY: LSG	
DATE: 4/10/89		REVISED:	
Fig 4. Georgetown Pump Station			
LA TERRE ENVIRONMENTAL CONS.			DRAWING NUMBER: 89-5-4

The property is a lot with grass and a few weeds. There is a capped standpipe at the northeast corner of the pumphouse. The standpipe is nine feet deep from its upper rim and contains one foot of rusty but not oily water. A test hole was dug three feet north of the pipe to a depth of 6.5 feet without any evidence of a tank. Either the standpipe is continuous or the tank is very small. A test hole dug adjacent to the pipe would answer the question in the future.

Eight samples were collected for PCB analysis on March 14. These included wipe tests inside the pump house and water/soil samples outside. The sample locations are shown in Figure 4. Testing methods and results follow.

In spite of the large sample size, the wipe tests performed inside the Georgetown pumphouse picked up very little PCBs. The concentration was too low for aroclor characterization, as was the case with the remaining samples. Since the concentrations found in the tests described here were so low, no recommendations for further sampling are made at this time.

The existence of an underground tank adjacent to the pumphouse was not disproven in this study, however, further exploration, such as excavation of the standpipe would have been recommended if the water sample had contained visible oil. No such oil was observed.
